# **Septic Tank Systems in the South African Coastal Zone**

**Report to the Water Research Commission  
by the  
Groundwater Programme  
Division of Water, Environment and Forestry Technology  
CSIR**

**WRC Report No 597/1/99**

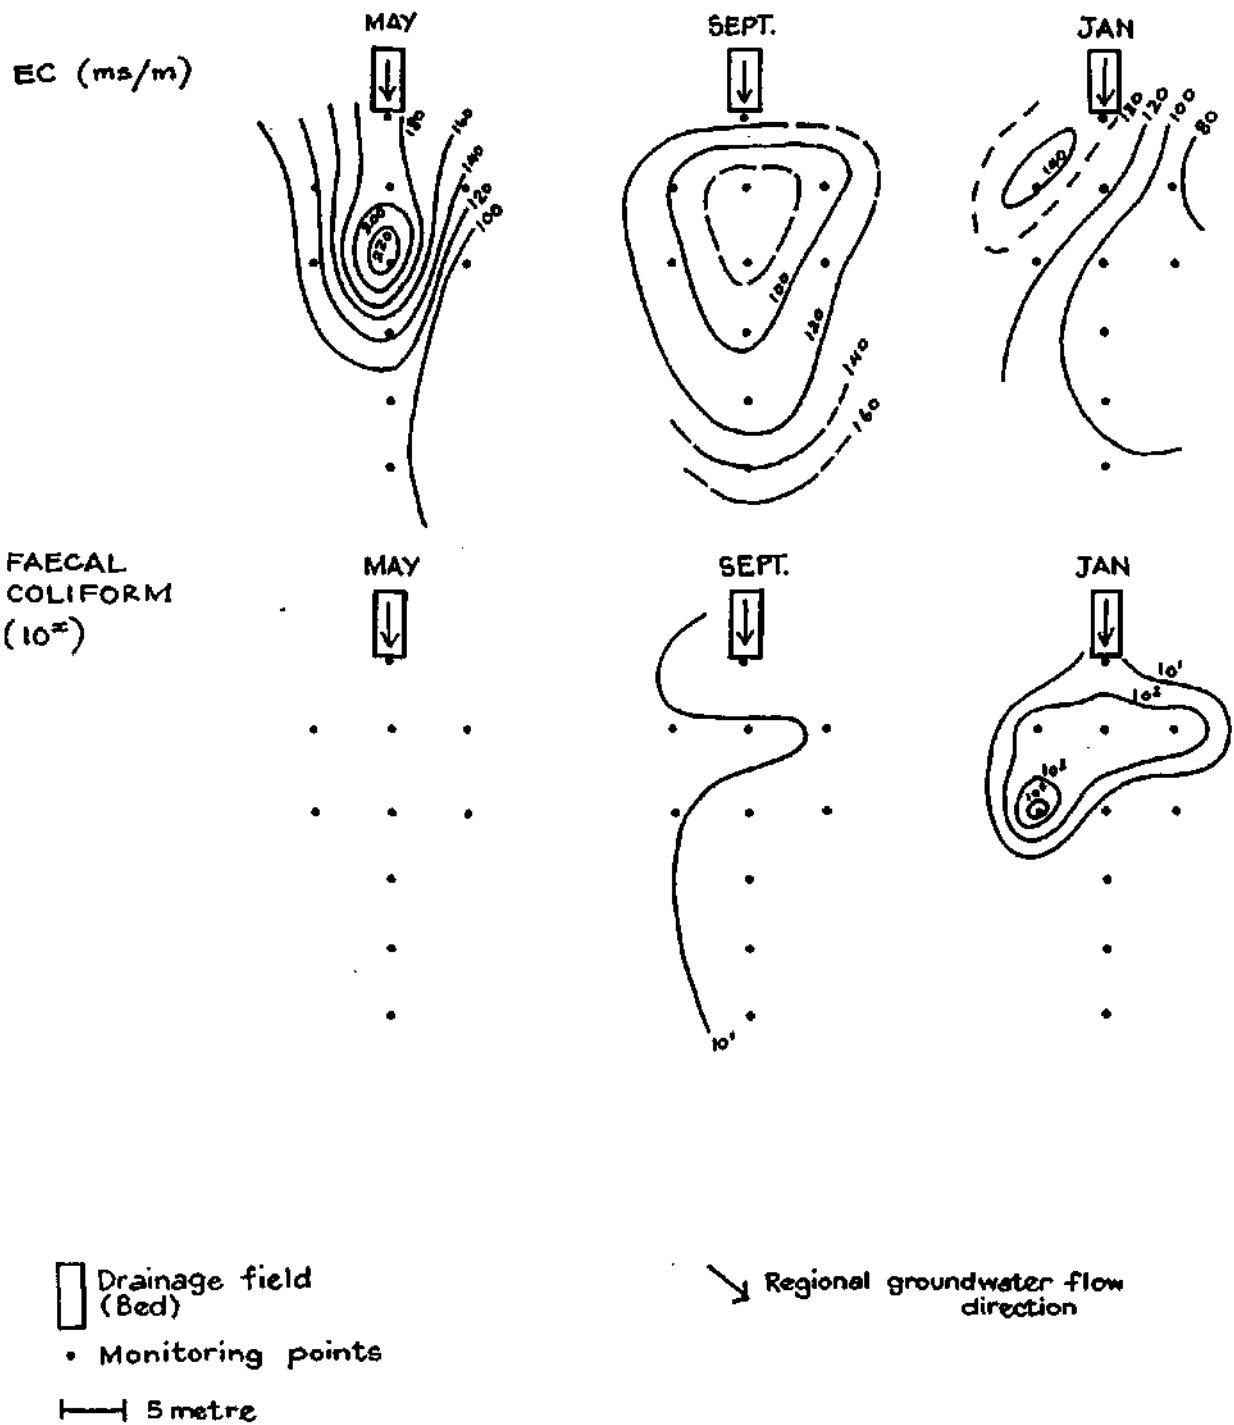
Figure B2 Selected contaminant plumes as observed at the domestic septic tank system in Onrus

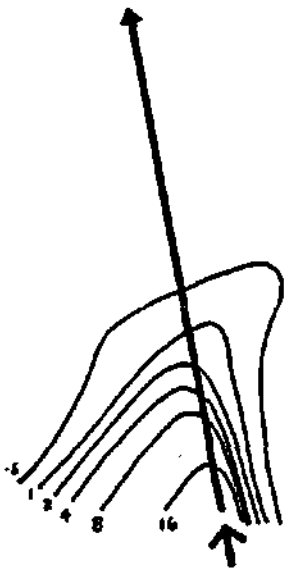
Figure B 6 The ammonia plume as observed at the caravan park ablution block site

**NH<sub>4</sub>-N:** The contoured plan (Figure B6) clearly indicates that effluent was only really discharged in significant volumes during the holiday periods (Christmas/New Year and Easter). Wellpoint SH 25 represents the background levels and remains at <0.01 mg/L throughout the year. The ammonia plume never extended further than 10 m from the trench and did not penetrate below the coarse horizon. The coarse horizon appeared to act as a zone of preferred flow. The bimodal nature of the plume in January (also reflected by the other constituents) indicates that effluent was not infiltrating uniformly down the length of the trench. In April all the effluent discharged into the trench infiltrated immediately, i.e. where the feeder pipe entered the trench. In January, however, a considerable volume moved down the trench and infiltrated some 10 m beyond the feeder pipe, larger volumes of waste water being generated during the Christmas/New Year period than earlier (April).

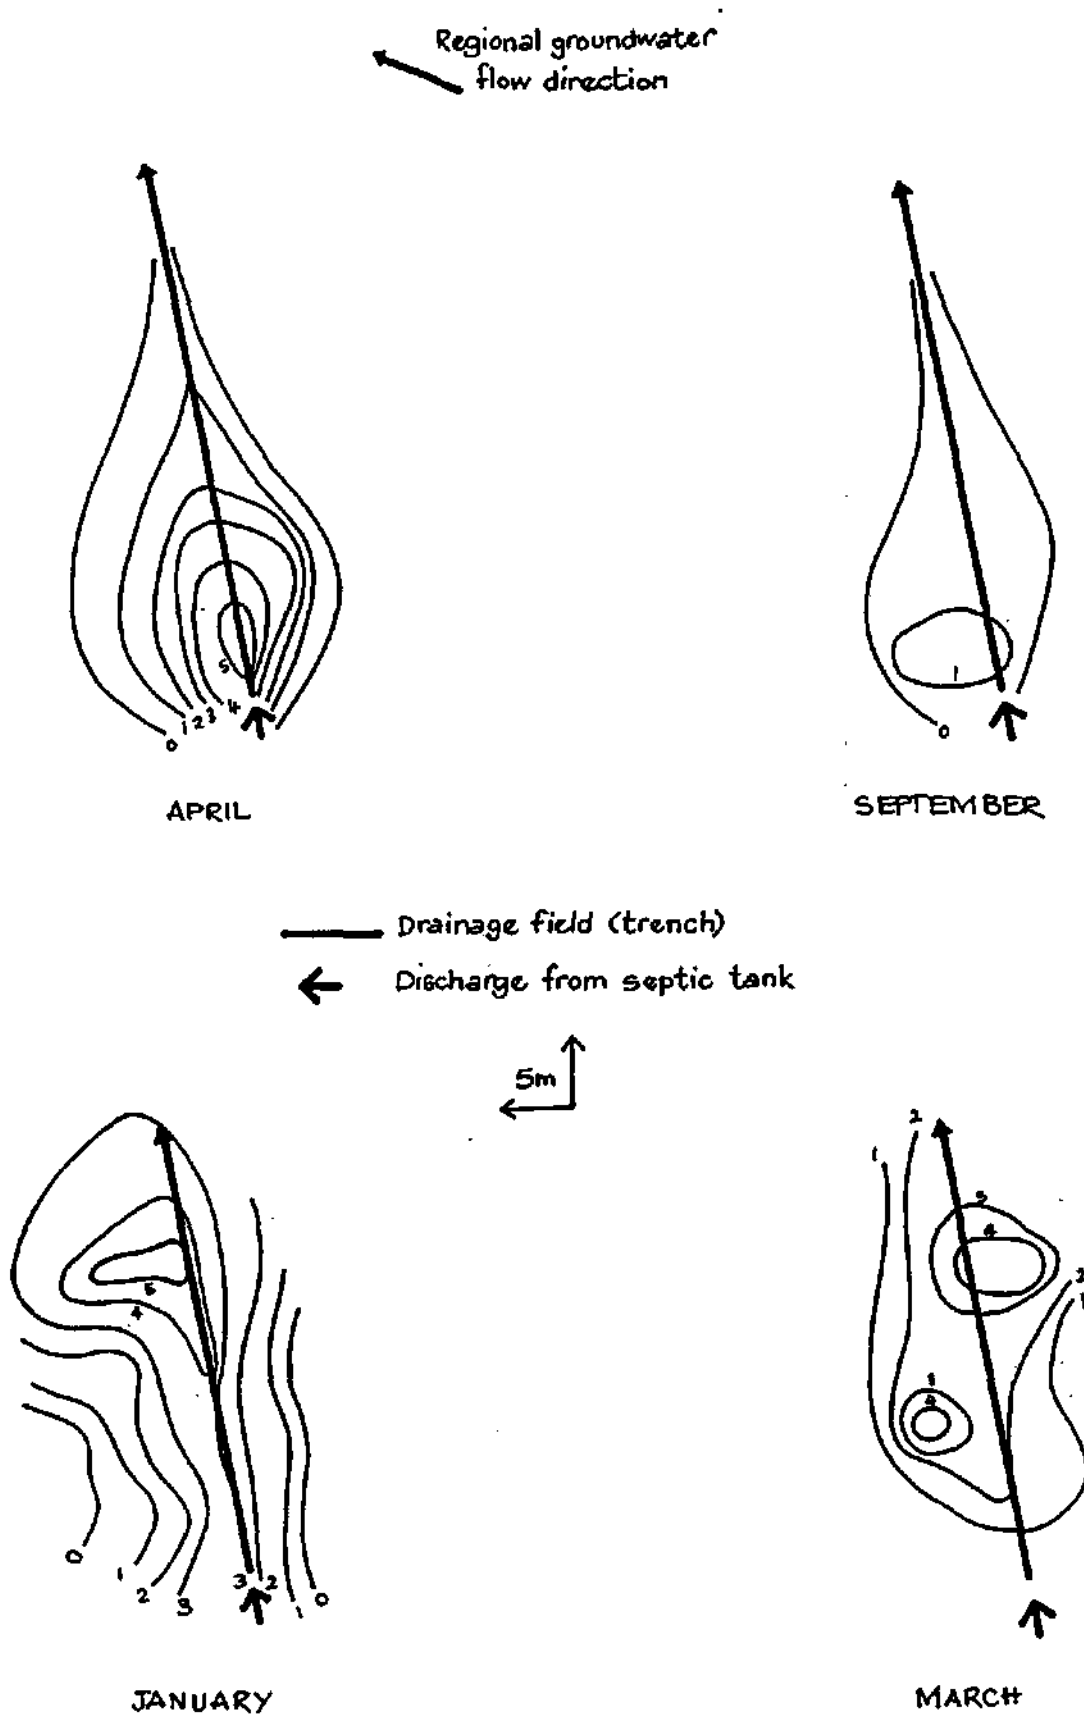
Figure B12 The faecal coliform plume as observed at the caravan park ablution block site

**Faecal coliform:** In April (Easter period) the effluent never really moved more than 10 m down the trench, with the majority of effluent infiltrating in the first 5 m. During the Christmas/New Year period, however, there was far more movement down the trench; it could be traced as far as 20 m from the discharge pipe. The greatest infiltration, however, occurred between 15 to 20 m, suggesting a degree of clogging in the first 10 m of the trench.
